ANALYSIS OF THE HYDROLOGIC, HYDRAULIC AND
_____ GEOMORPHIC ATTRIBUTES OF THE
YOSEMITE VALLEY FLOOD: JANUARY 1-3, 1997

Technical Report NPS/NRWRD/NRTR-97/129

July 1997

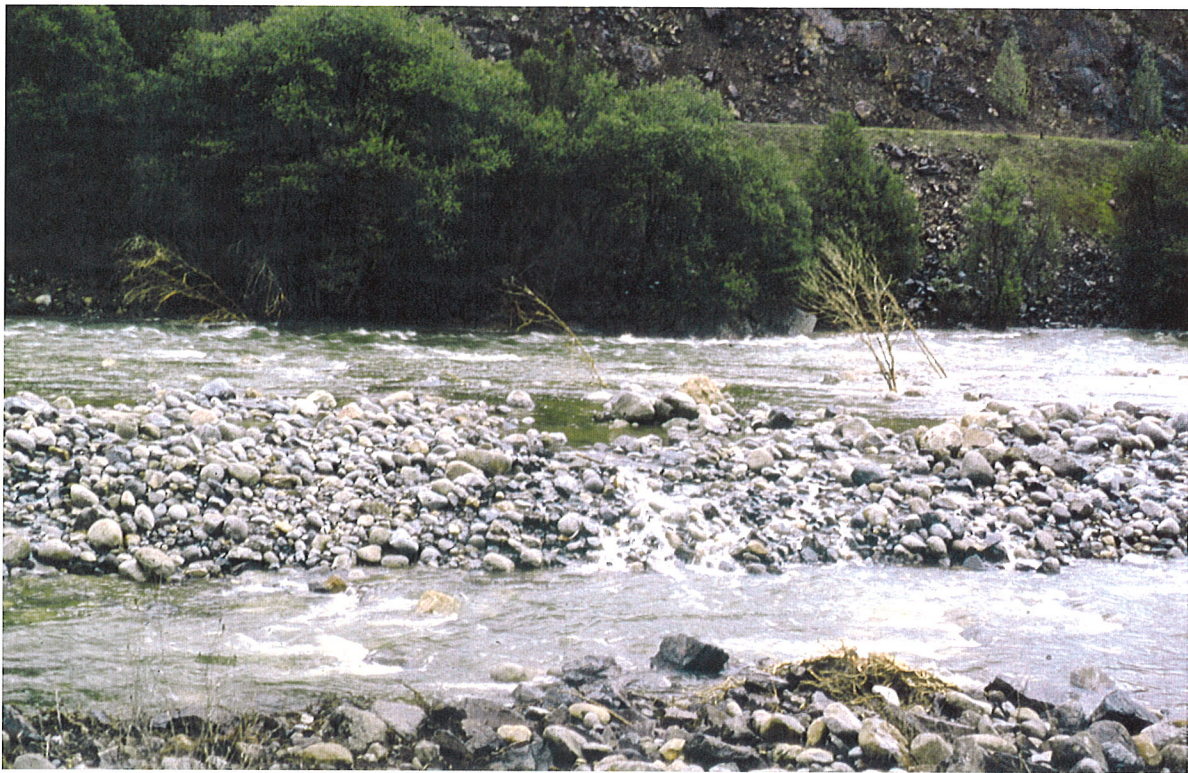
The flood in this reach was deep (15-30 feet) and generally confined by valley walls or by the road prism. Velocities were extremely high and flows were supercritical. Stream power and sediment transport energies were enormous. At some locations enough valley width existed for the pre-flood river to have established some slight sinuosity and side-channel bar deposits. During the flood, the river went straight down-valley, typically cutting off bar deposits and scouring any vegetation established on them (Figure 5). Many significant changes to channel alignment and character were made during the flood. Interestingly, very little disturbance to hillslope (non-riparian) natural resources was observed in undeveloped reaches downstream from the diversion dam.

The primary flood effects in this reach involved impacts to the road and utility corridor. This was a deep, high-energy flood. In places the flood mobilized the rock riprap placed to protect fill material used to construct the road prism. This resulted in erosion of the road prism and undermining of the road surface. In other places high-energy flows over-topped the road and flowed down the road, eroding fill material under the road surface and eventually undermining the road surface and causing it to fail and/or wash away.

Figure 5. Photo of post-flood Merced River channel in Reach 1 near El Portal.

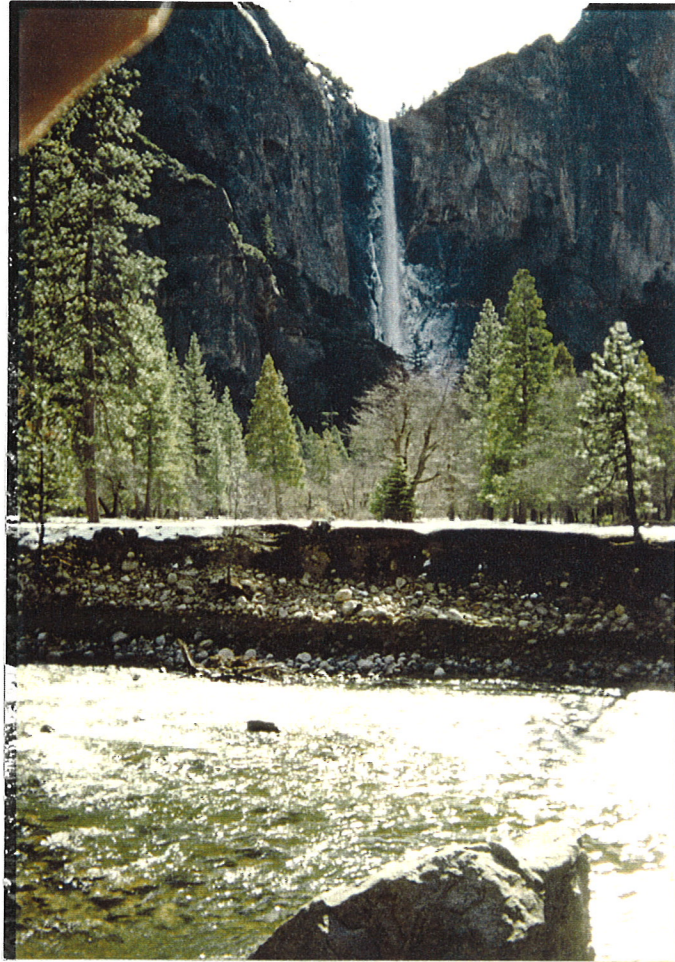
Figure 6. Photo of post-flood Merced River channel in Reach 2 where it passes over Bridalveil Moraine. Some streambank erosion is evident in this photo.

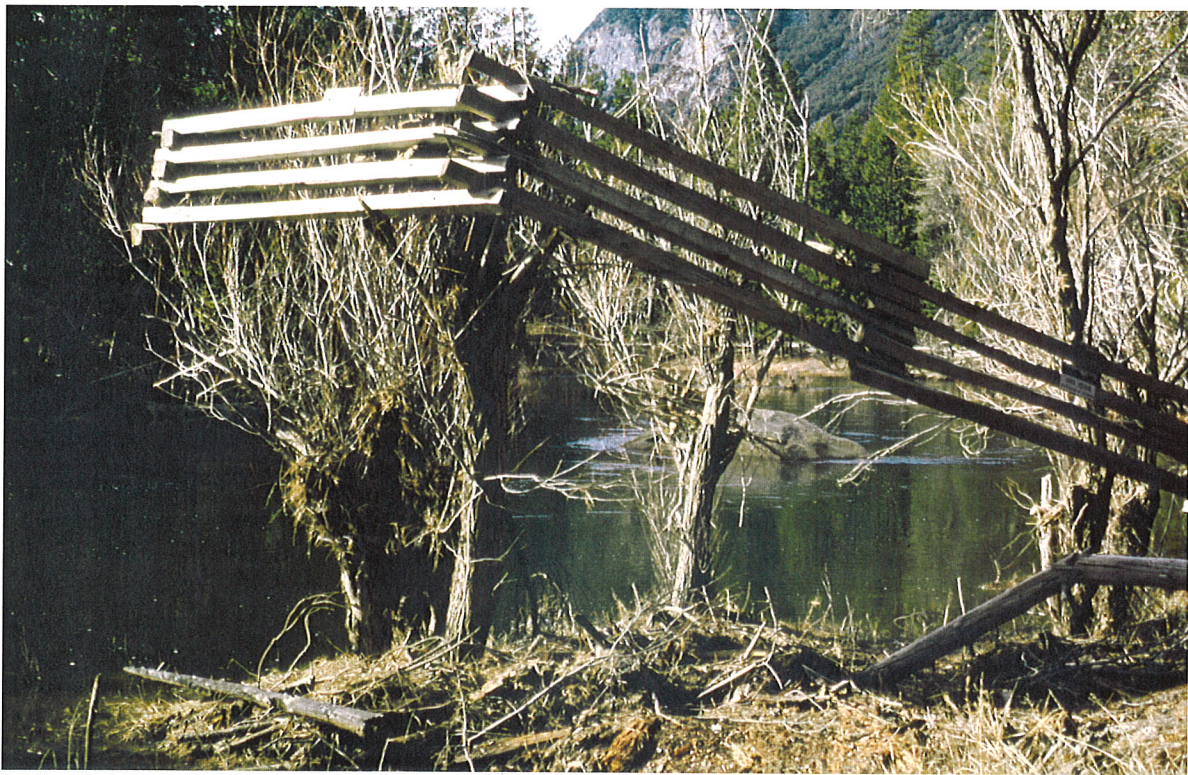
Although flood depths in the reach from El Capitan Moraine to Housekeeping Camp were generally great, for the reason given above, flood velocities were generally very low. One of the most noteworthy things about the flood in this reach is that there is so little evidence of geomorphic response. There are very few readily observable changes to the river channel, floodplain or riparian vegetation in this reach. Impacts to infrastructure stemmed primarily from inundation and rafting of unsecured floatable objects (Figure 7). For structures such as bridges and roads, there is very little consequence stemming from inundation in absence of significant velocity. It is also interesting to note that even floating trees and other large woody debris caused no significant damage to bridges because flow velocities were so low. In general and for the same reason, buildings also realized little structural damage from flowing water or debris.

Figure 7. Photo of wooden fence, which was floated but not significantly damaged by impounded water in Reach 3 upstream from El Capitan Bridge.

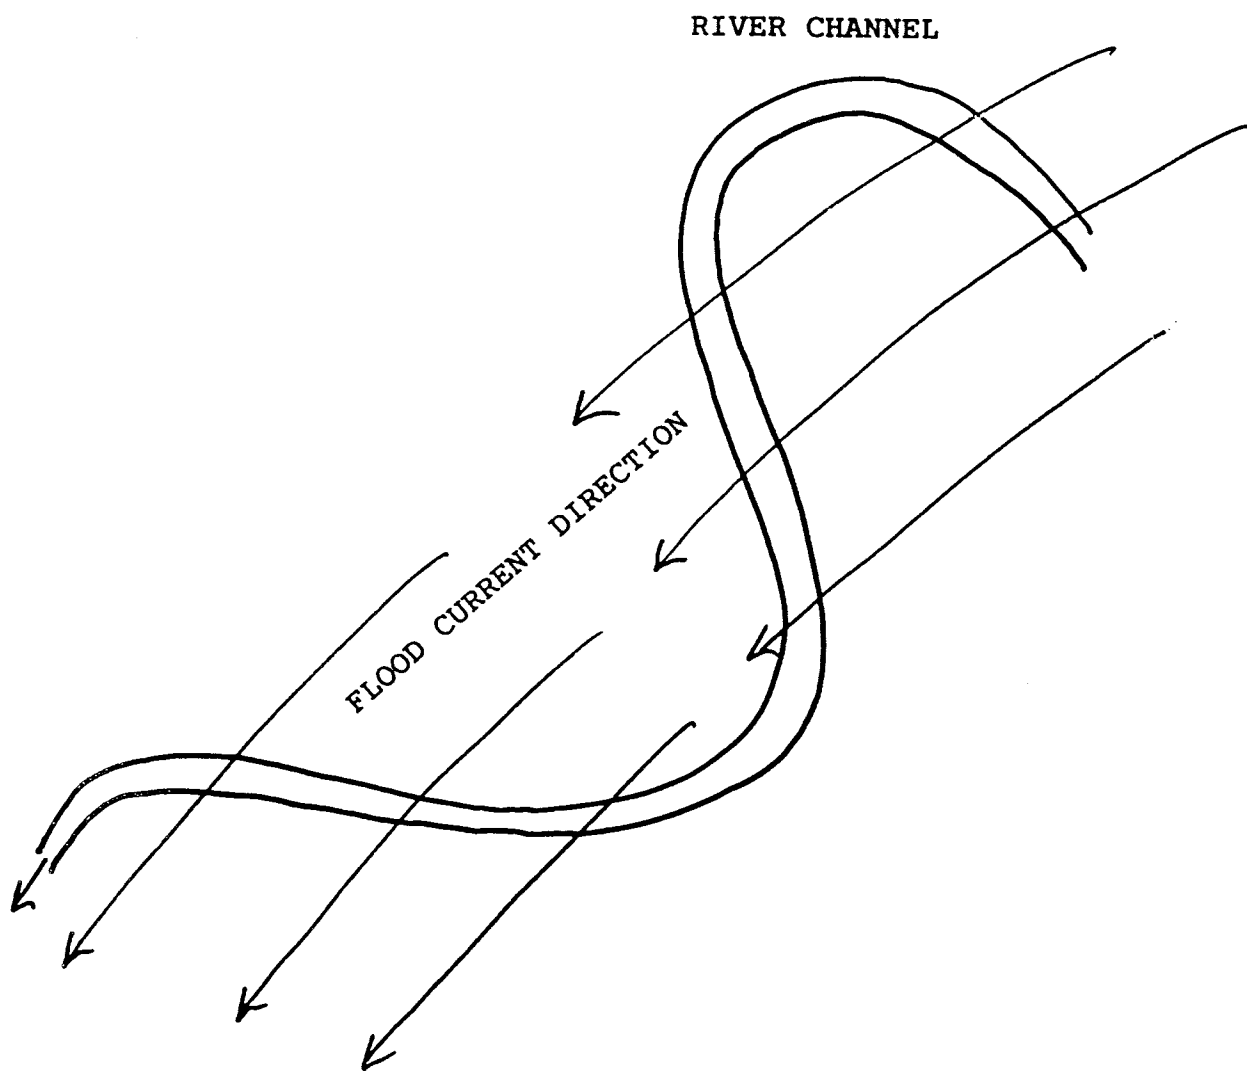
Campground developments including roads, bathrooms, picnic tables, bear boxes, and fire rings were heavily impacted, and often relocated downstream by the flowing water. In addition, water flowing across the meander necks resulted in adjustments to the river channel and floodplain. Flood channels cut across meanders, and there were areas of localized sediment deposition - both on floodplains and in channels. Also, there were areas of bank erosion, usually at the outside bends of meanders. Much of the resource adjustment which occurred was probably exaggerated by the poor condition of vegetation cover on floodplains and banks. Also, bridges, such as Sugar Pine Bridge, had inadequate capacity to convey the full flood discharge and functioned to cause additional flow to cut across meanders.

Figure 8. Sketch depicting the direction of flood flows across meanders.

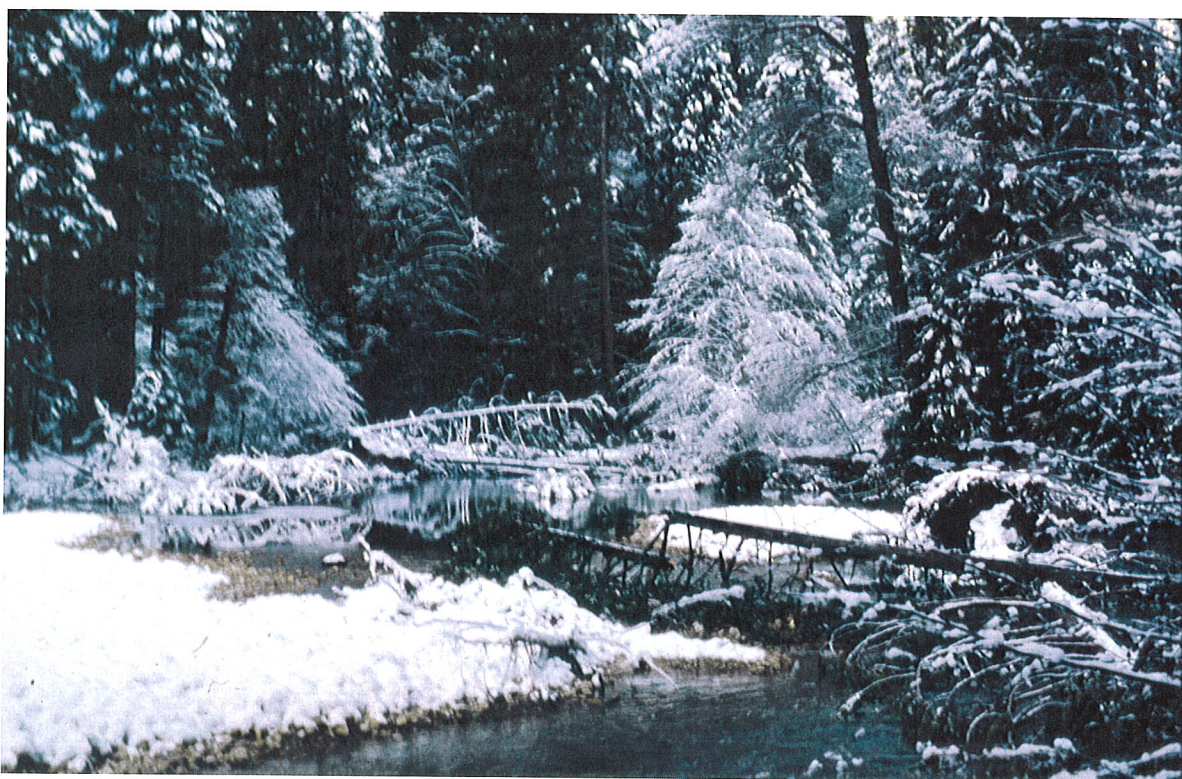
These are high-energy streams during flood events. Water is largely confined within the channel and valley walls and flows directly down-gradient. Flood flows caused minor impacts to infrastructure in this reach. A foot bridge downstream from Mirror Lake was washed out and there was erosion of the road shoulder along the road to Mirror Lake. The confluence of Tenaya Creek with the Merced River is a depositional zone. Flows during this flood concentrated their out-of-bank energies on the right side of the Tenaya Creek alluvial fan, in the area of the Group Camp. Here there was erosion of the campground and impacts to picnic tables, bear boxes, fire pits and garbage containers.

By far the most dramatic effect of the flood along the lower Tenaya Creek and the Merced River upstream from Tenaya Creek confluence involved the downing of trees and the enormous amounts of transported woody debris (Figure 9). The energies of this flood were sufficient to undermine mature trees on the river banks, causing them to fall into the river. Once in the river, trees interacted with flows to cause local areas of bed material deposition and bank erosion (and additional tree fall). Upon recession of the flood, enormous amounts of woody debris remained in the river channel and overbank areas.

Figure 9. Post-flood photo of the Tenaya Creek channel upstream from the Group Campground.

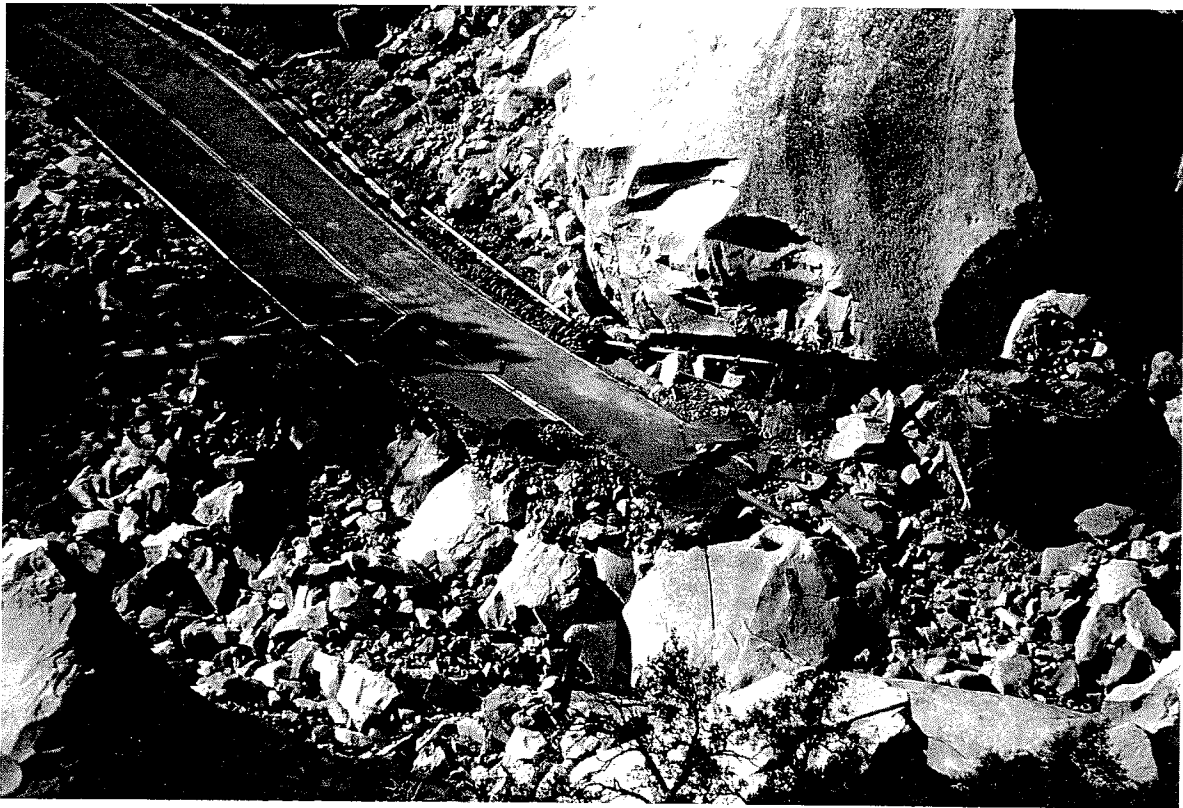
The Cookie Slide area is in the same high energy reach as El Portal and, therefore, experienced the same devastating hydraulic conditions. The difference between this area and the El Portal area is that the channel is more resistant to erosion here and, therefore, less geomorphic response was realized. Also, because less infrastructure is present (only El Portal Road and utility corridor) there was less opportunity for impacts to park facilities. In several locations, the road embankment was eroded causing partial failure of the road surface. Also prevalent were zones with insufficient local drainage. Where culverts became blocked or were insufficient in number and/or size, flow in ditches parallel to the road caused widespread damage.

By far the most notable damage in this area and, for that matter, anywhere within the park proper, is the obliteration of a 300-400 foot section of El Portal Road (Figure 10). The park sewer line located under the road also was completely severed in this area. This damage was caused by the flood level exceeding the elevation of the road (by upwards of 4 feet) just upstream from a confined length of roadway. The confinement is caused by a talus slope with very large boulders bordering the road on both sides. When river flow entered the road, it traveled down the steep grade at a high velocity, tearing asphalt and road base apart and washing this material nearly completely away. This segment of road has repeatedly been damaged by high flows but nothing of this magnitude had been experienced in the past. One reason the devastation was unprecedented, besides the extremely high discharge, is that a landslide occurred in 1982 that left additional boulders along the road that lengthened the confined area and extended the amount of road length impacted by high-energy water flowing over the surface.

Figure 10. Photo of Cookie Slide area on El Portal Road between Yosemite Valley and El Portal.

Several steps can be taken to improve performance of this segment of road during flood events. Two ideas proposed by Federal Highway Administration engineers include raising the road at the break-out point and blasting some of the recent landslide material to allow the flow to return more quickly to the channel. We think these are good ideas that would reduce future repair costs substantially. The amount the road is elevated can be dictated by practical considerations related to the road grade. Any additional elevation at the break-out point will not only provide a higher level of protection but reduce the amount of flow down the road when overtopping occurs. Beyond these suggestions we think that placement of more culverts and use of grouted riprap where embankment protection is deemed essential should be considered. Finally, in some cases it may be cost-effective to tolerate some level of damage from low-probability floods in some difficult locations rather than attempting to design the road to withstand extremely rare floods.

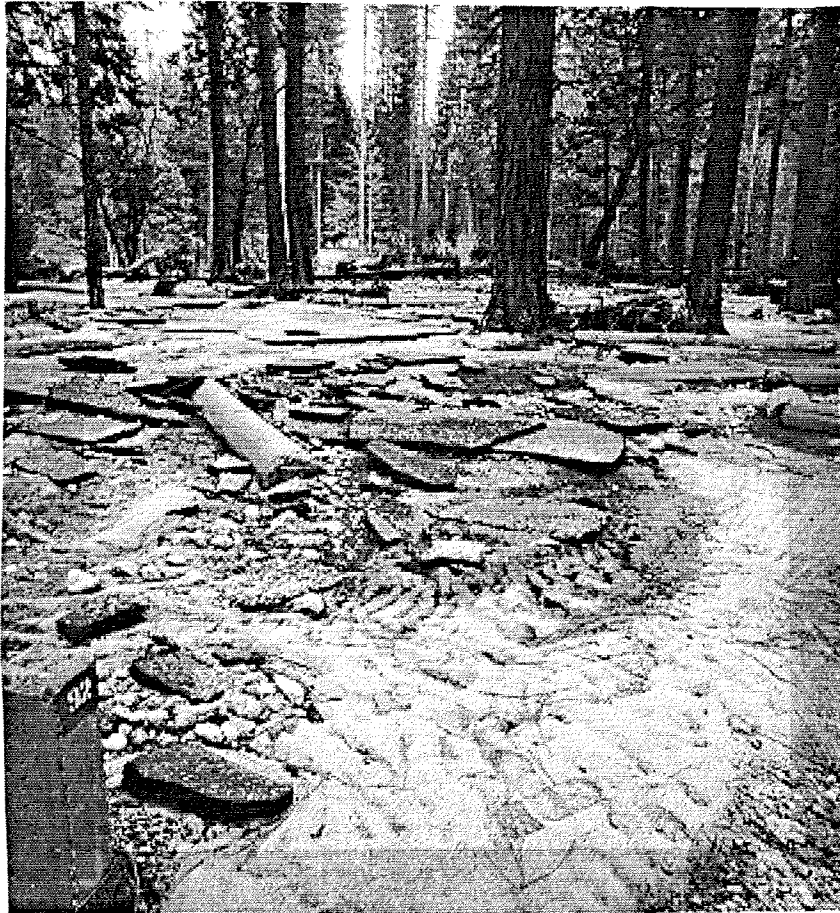
These factors conspired collectively to cause moderate depth but high velocity flow through much of the campground during the recent flood. While many of the park's campgrounds were damaged by the flood, none of the other sites we visited were affected as much as Lower Pines Campground (Figure 11). Flowing water rearranged everything that was not fixed in-place. In much of the campground, asphalt pavement on roads and parking spaces was peeled by the flow, broken up, and transported. The cutoff channel associated with Sugar Pine Bridge and the bike path enlarged greatly during the flood and appears to have become the primary path for flood waters through this reach. Other smaller channels were eroded further upstream in the campground above the effect of the bridge. This material was transported down-valley and some of it was redeposited on the left bank of the river downstream from Ahwahnee Bridge where overland flow velocity was reduced by high depths in the river.

At a point approximately 2/3 of the distance upstream on the meander bend, there is a rise in elevation on the meander neck. Campground units on this higher floodplain level experienced little or no flooding. All other Lower Pines Campground campsites are located low on the floodplain and will experience frequent flooding in the future.

Figure 11. Post-flood photo of Lower Pines Campground.

The following discussion presents several factors to consider in planning for repair or rehabilitation of this area. First it should be recognized that much of Lower Pines Campground is in an area susceptible to damaging hydraulic conditions during floods. Conditions experienced during the January flood will be experienced periodically in the future and, therefore, investments made to rebuild camping facilities or other infrastructure in this location will continue to be subject to flood risk. Certain areas in the camp, furthest upstream, were located favorably from a flood standpoint and can be considered to be at very low-risk. Also, portions of other nearby campgrounds experienced little damage during the flood and represent the best available areas to use as camps in this part of Yosemite Valley. Much can be gained by identifying these locations and incorporating this knowledge into the decision making process.

There is the possibility that the threat of flooding may be somewhat lessened in the future by the proposed removal of Sugar Pine (and possibly Ahwahnee) Bridge(s) and the bike path prism. However, nearly all of the camp area damaged by the recent flood is naturally prone to flooding as high flows bypass river meanders, a character that will remain with or without bridges. Additionally, the large cutoff channel associated with Sugar Pine Bridge has become so large that it probably cannot be rehabilitated at this point. Therefore, significant flow will likely continue to be directed through the cutoff channel in future floods even in absence of the bridge and elevated approach road. However, significant benefit to riverine resources will result from removal of this bridge (and Ahwahnee) and removal is recommended to promote a more naturally functioning fluvial environment. Bridge removal would be beneficial to natural processes by among other factors reducing the proportion of flow entering the cutoff channel and allowing a stable bank configuration to develop on a significantly shorter time frame.

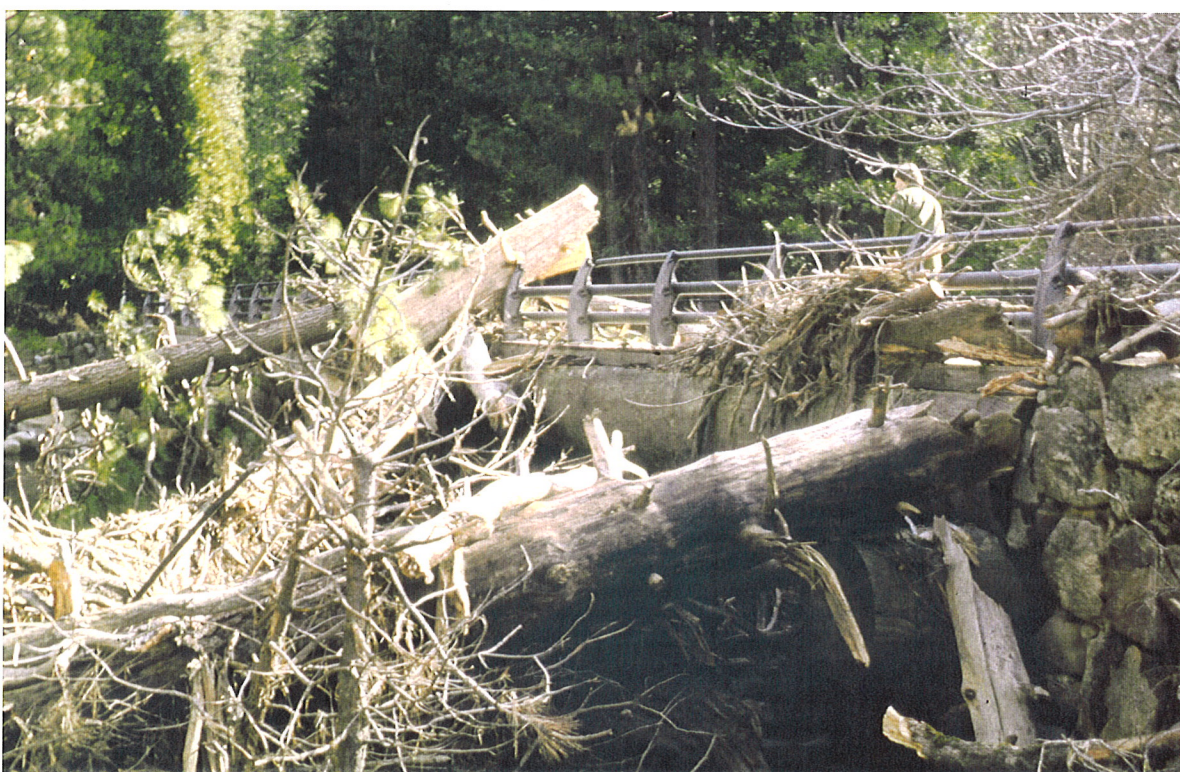
Figure 15. Photo of large woody debris piled up against El Capitan Bridge.
This debris was floated by impounded water behind El Capitan Moraine.
However, because velocities were low, very little damage was done to the bridge.
